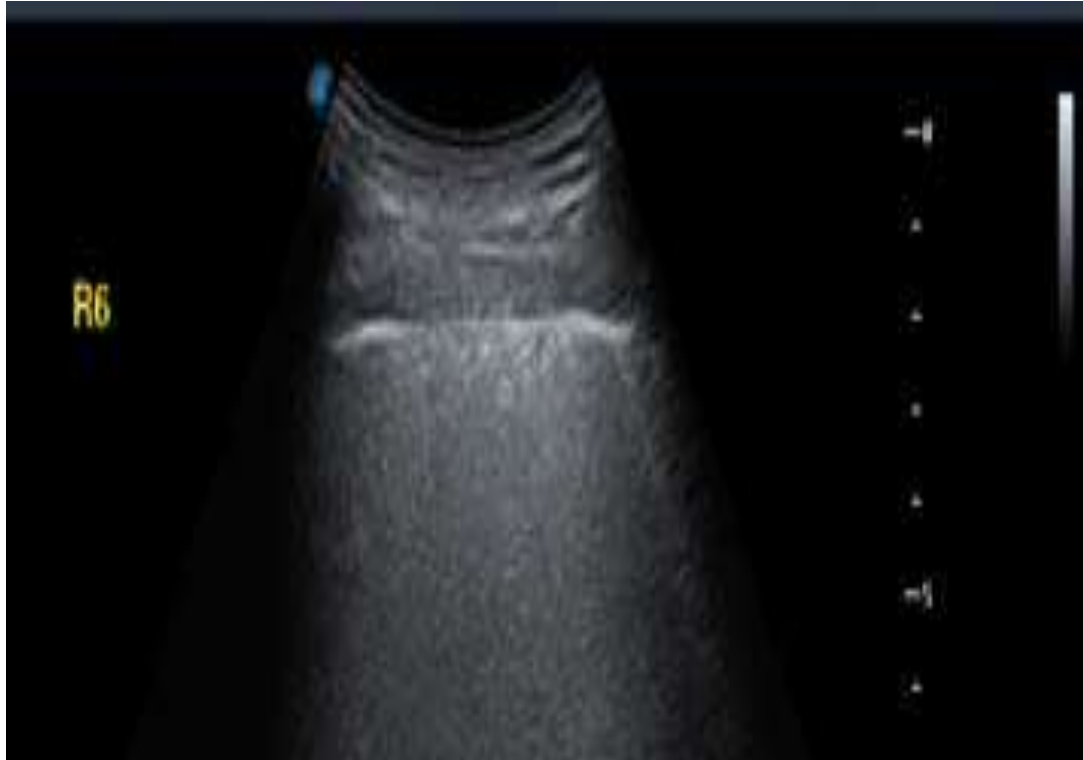
Figure(1) the convex array probe showed the pleural line in the right posterior lower area was unsmooth and thin with diffused B lines and "white lung" sign (12).

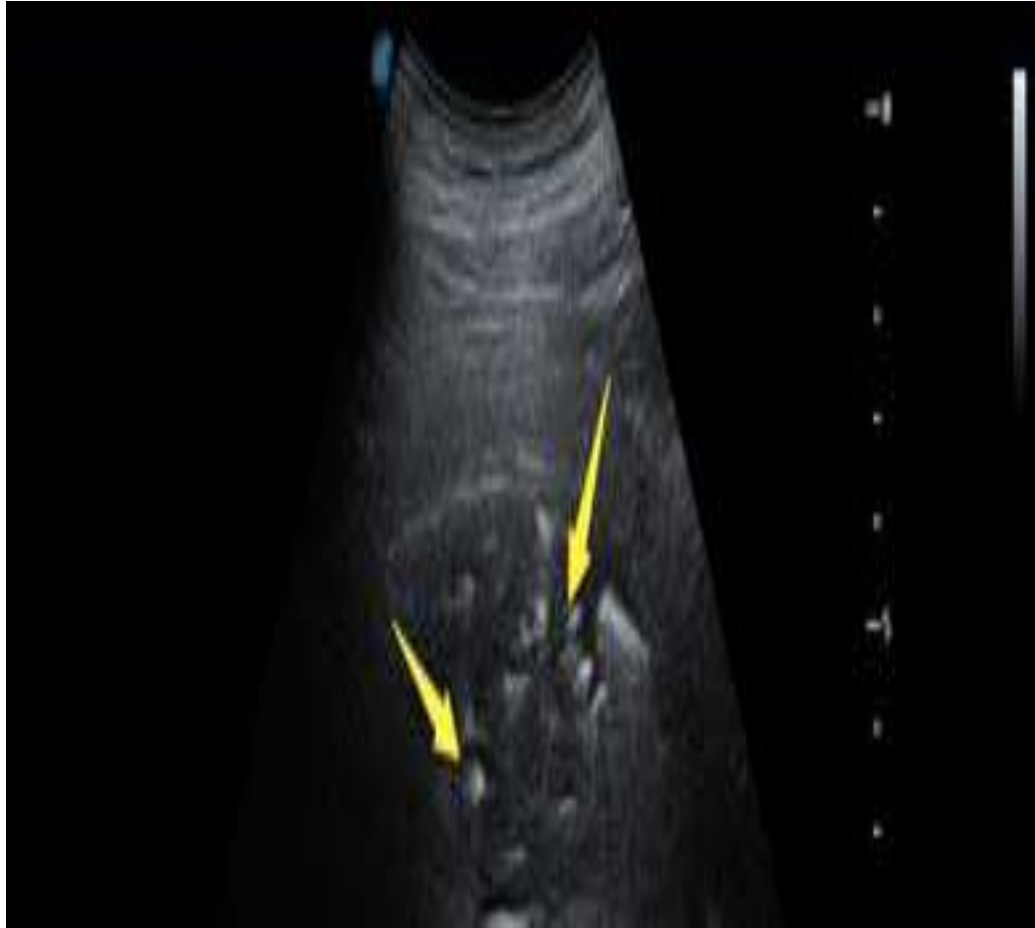
Figure(2)convex array probe showed large areas of consolidation in the right posterior upper area and airbronchogram sign (yellow arrow). The pleural line was interrupted (12).
