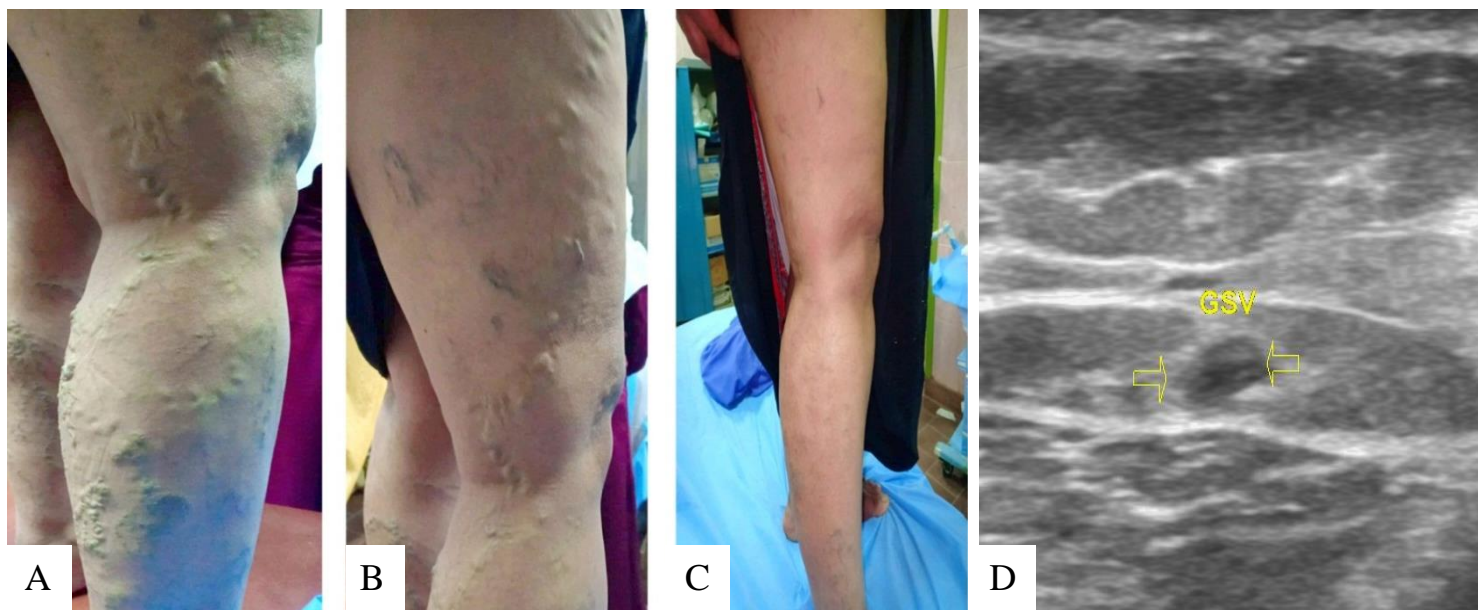
Figure 33 Case no. 2: (A) (B) marked visible varicosities. (C) After three sessions of UGFS, Showing significant improvement. (D) Ultrasound study, the GSV thrombosed and non-compressible with marked reduction in diameter.

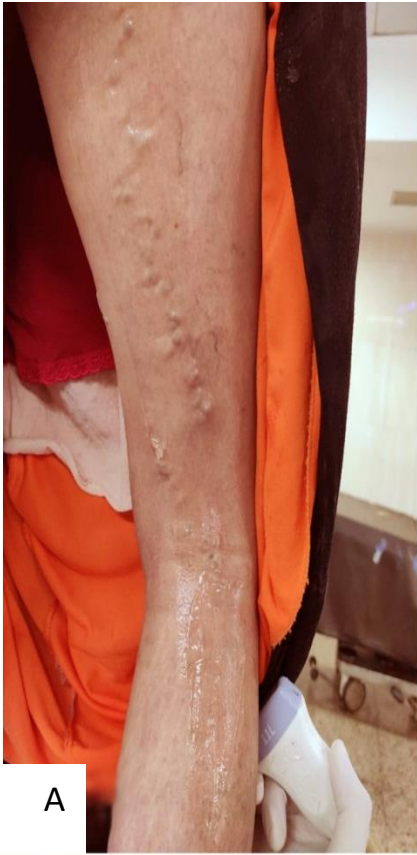
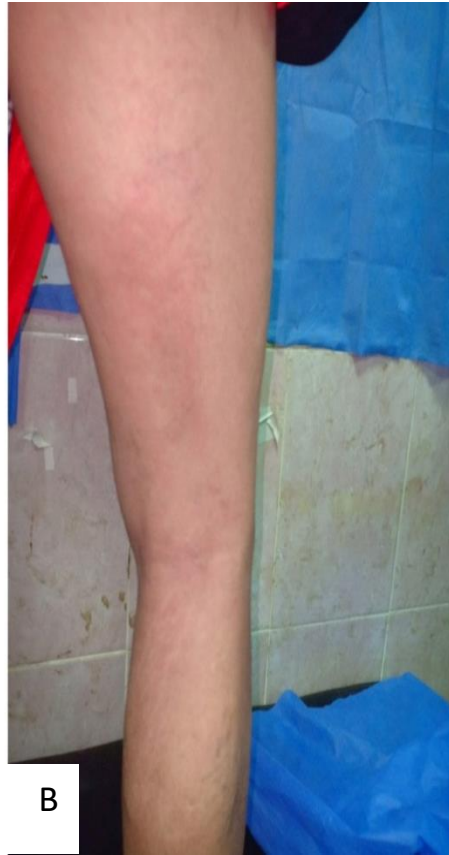
Figure 37 Case no. 6: (A) Large sized subcutaneous varicosities seen at posterior aspect of thigh. (B) No visible varicose vein after UGFS. (C) Ultrasound showing complete thrombosis of treated vein.
