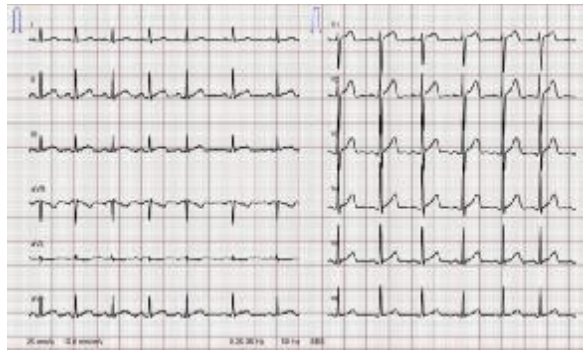
**Figure 1** 12 lead ECG) showing normal sinus, normal left axis, 1-2 mm ST-elevation in precordial leads V1-V3.

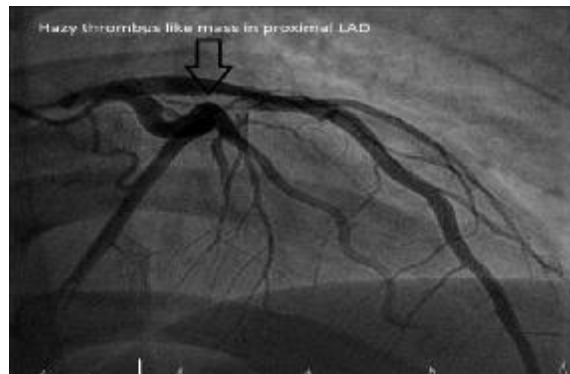
**Figure 2** Coronary angiography RAO 15/CR 30 views showing hazy thrombus like mass in proximal LAD.

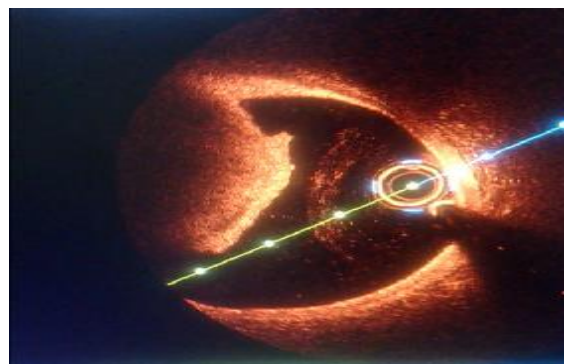
**Figure 3** OCT image using C7 DRAGONFLY™ ( St. Jude Medical) confirming the presence of thrombus in proximal LAD.

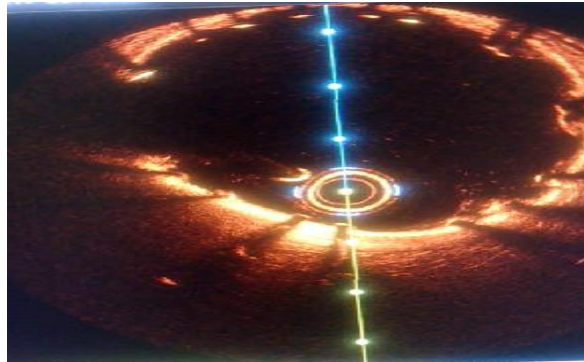
**Figure 4** OCT image using C7 DRAGONFLY™ ( St. Jude Medical) showing mild stent apposition in proximal LAD.

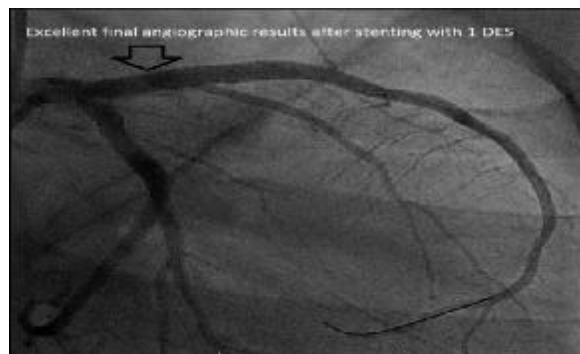
**Figure 5** Coronary angiography RAO 25/Caudal 33 view showing excellent final angiographic results after stenting with 1 DES.
